Re: Lake-Leonard-Grandview Intersection Review

Progressive AE has completed the traffic and safety review of the existing Lake Avenue/Leonard Road/Grandview Avenue intersection located in the southeastern portion of the Village of Spring Lake (Village). Our comments and recommendations stemming from our analyses are summarized in the following sections.

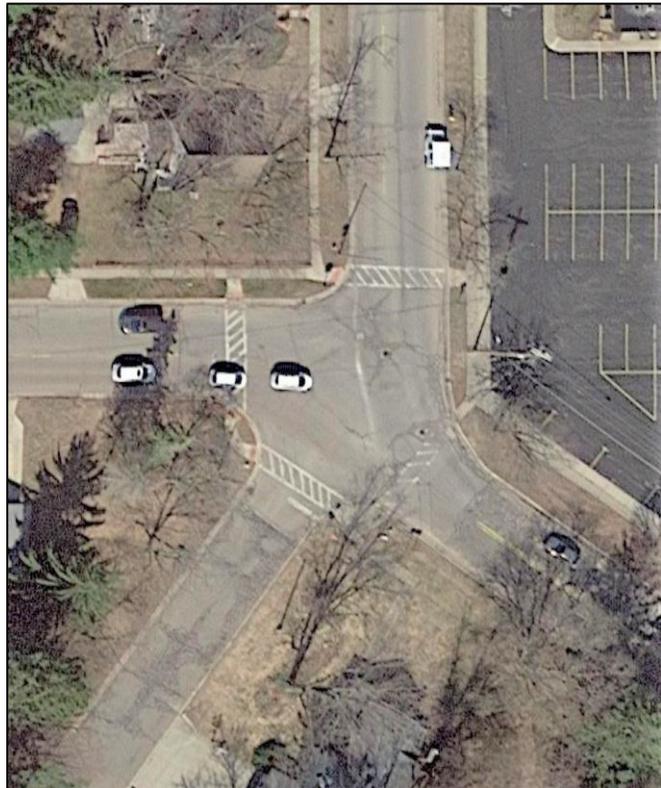
Eight (8) crashes over a 5+ period is considered low, even for an intersection that experiences relatively low traffic volumes. The crash history also indicates the Lake Avenue-to-Leonard Road curve is the primary geometric issue as opposed to the overall odd shape of the intersection, although even then it is mainly just during icy conditions.
